Van Hool CX45

Loose R110 Resistor Connection Fix

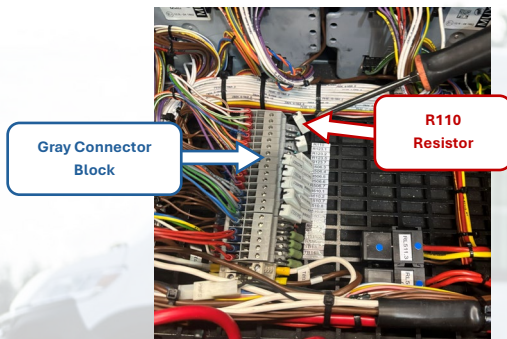
If you are experiencing sub-optimal fan speeds (little to no air flow) from your vehicle's AC evaporator unit, then there may very well be a **loose wiring connection** within the **R110 resistor**. Please follow the steps below to re-establish proper connection:

2. **Locate** the **R110 resistor** within the **gray connector block**.
