| <b>VEHICLE TYPE</b> | : CX45 MY2023 |
| <b>BULLETIN TYPE</b> | : <b>Field change program</b> |
| <b>SUBJECT</b> | : <b>Inspection of automatic belt tensioner base plate fasteners</b> |

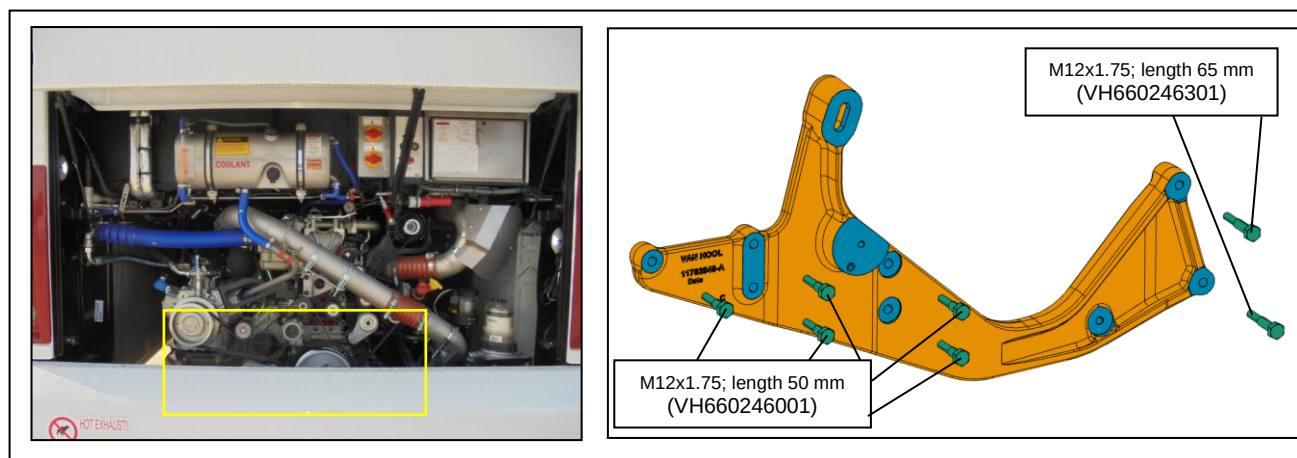
Van Hool has determined that some of the seven fasteners securing the automatic belt tensioner base plate are subject to slackening. Tests have shown that these fasteners must be installed with Loctite 243 and tightened to a torque of  $90 \pm 10$  Nm ( $65 \pm 7$  ft.lbf).

**Figure 1: Location of the fasteners securing the automatic belt tensioner base plate**

| Step | Action |
|---|---|
| 2 | Remove one of the seven affected fasteners (refer to figure 1). |
| 3 | Identify the length and thread pitch of the fastener (refer to figure 1). <ul style="list-style-type: none"><li>• <b>If length and thread pitch are okay:</b> clean the thread of the fastener removed. Apply Loctite 243 on the thread and re-install the fastener with a torque of <math>90 \pm 10</math> Nm (<math>65 \pm 7</math> ft.lbf).</li><li>• <b>If the thread pitch is okay, but the length is not:</b> take a fastener with the proper length. Clean the thread of the fastener. Apply Loctite 243 on the thread and install the fastener with a torque of <math>90 \pm 10</math> Nm (<math>65 \pm 7</math> ft.lbf).</li><li>• <b>If the length is okay, but the thread pitch is not:</b> temporary re-install the 1.5 mm thread pitch fastener with a torque of <math>90 \pm 10</math> Nm (<math>65 \pm 7</math> ft.lbf) and contact ABC to determine the next step.</li></ul> |
| 4 | Repeat steps 2 and 3 for the six other affected fasteners. |
