| <b>VEHICLE TYPE</b> | : CX45 with electric cooling fan drive |
| <b>BULLETIN TYPE</b> | : <b>Field change program</b> |
| <b>SUBJECT</b> | : <b>To install a refrigerant compressor bracket reinforced anchoring point</b> |

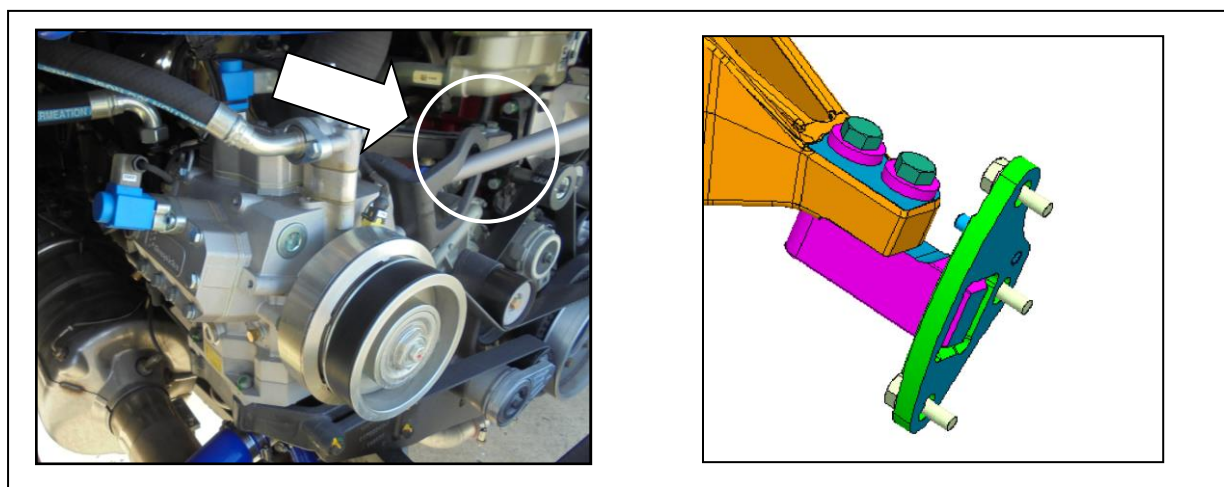
VDL Van Hool has determined an issue regarding the refrigerant compressor bracket anchoring point at the engine side on the above mentioned vehicles.

Figure 1: Refrigerant compressor bracket anchoring point

To address this issue, VDL Van Hool is conducting a field change program whereby the anchoring point must be replaced by a reinforced type. What to do exactly is explained in this service bulletin.
