COACH MODEL : 2020 CX45, CX35 (Multi-Vu Professional / MVP)

DATE : 3/16/2020

SUBJECT : Auto-Elevate

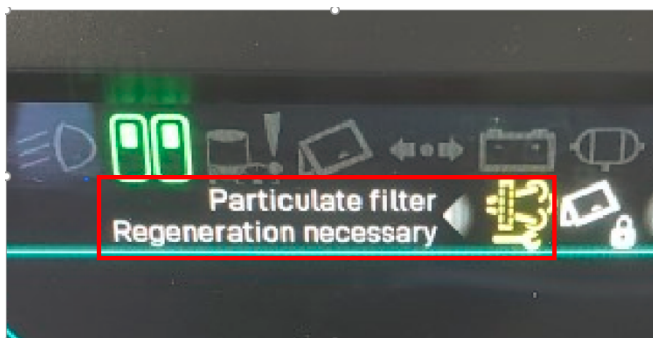
Figure 1 Auto-Elevate

When Auto-Elevate is engaged on the 2020 CX with the MVP dash, engine RPM's will increase and the message "Particulate filter regeneration necessary" along with the regen symbol and **wrench** will display on the MVP.(Fig 1) While similar in appearance to the regen required message. (Fig 2) The notable difference between the two messages is the **wrench** symbol.

The Auto-Elevate message **Does Not** require a regen and no action is required by the driver. The driver can either wait until engine RPM's return to normal or interrupt the process if they need to drive or move the coach. Auto-Elevate will resume if needed when stopped again.
