ADDRESSEES	: Owners and operators of vehicles mentioned under "Application" ABC Customer Care and Parts Source
VEHICLE TYPE	: CX45 MY2023/2025
CONFIGURATION GROUP	: 2.34 Traction motor – Cooling system
BULLETIN TYPE	: Field change program
DATE	: December 05th, 2025
SUBJECT	: To install additional supporting point for cooling pipes
CONDITIONS	: Refer to chapter "Warranty" further on in this bulletin.

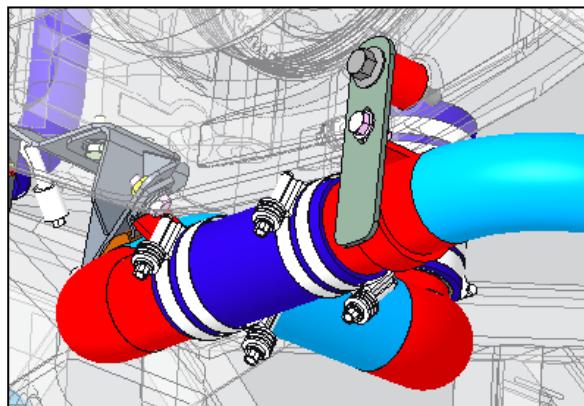
VDL Van Hool has been informed about an issue regarding some cooling pipes supporting points on the above mentioned vehicles.

Figure 1: Additional cooling pipe supporting point (at rear of vehicle)

To address this issue, VDL Van Hool is conducting a field change program whereby the front and rear supporting points indicated in figure 2 must be checked for possible damage. In addition, an extra cooling pipe supporting point (figure 1) must be installed at the rear of the vehicle.

Step	Action
1	Check the front and rear supporting points indicated in figure 2 for possible damage. If necessary, replace the omega clamps and related saddles. Tightening torque for M8 nut securing omega clamp to bracket: $21 \pm 3 \text{ Nm}$ ($15 \pm 2 \text{ ft.lbf}$)
2	<p>CAUTION!</p> <p>It is important that the silicone hose still has been aligned regarding to the cooling pipes after the installation of the additional supporting point. If necessary, adjust the position of the existing supporting point at the left.</p> <p>Install the additional supporting point.</p>

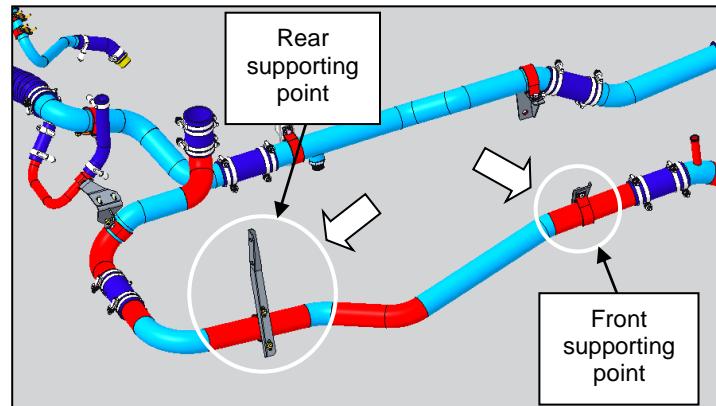
Figure 2: Location of front and rear supporting points to be checked for possible damage
