**COACH MODEL**

CX35 &amp; CX45 with Eberspächer Heater Units

Coolant Leak Fix; 17mm Bolt Adjustment

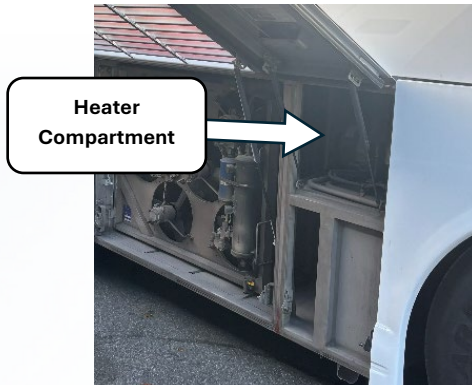
1. **Turn off** the coach and **open** the heater compartment door (roadside of the coach).

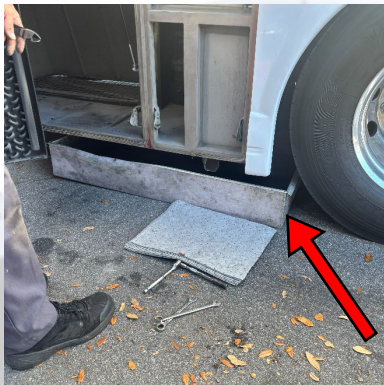
2. **Place** a drain pan underneath the heater compartment to catch any coolant discharge.

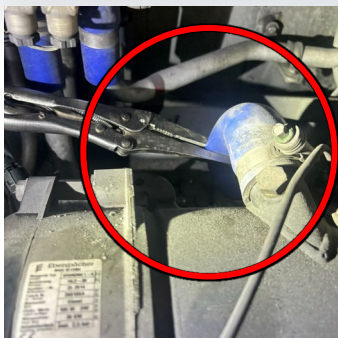
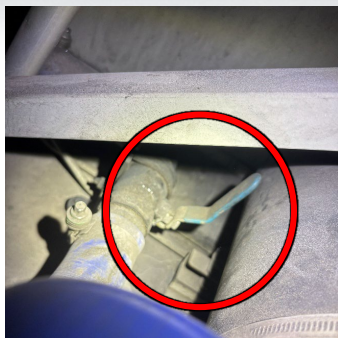
3. **Clamp** the backside heater hose, then **close** the supply shut-off valve (located behind the heater).

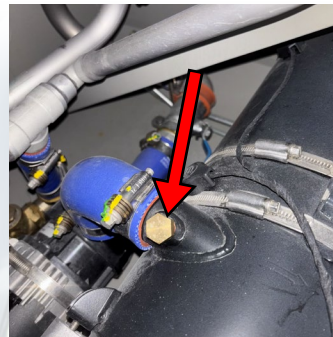
4. **Remove** the 17mm bolt and **inspect** the O-ring for any damage. If necessary, **replace** the O-ring before re-installation.

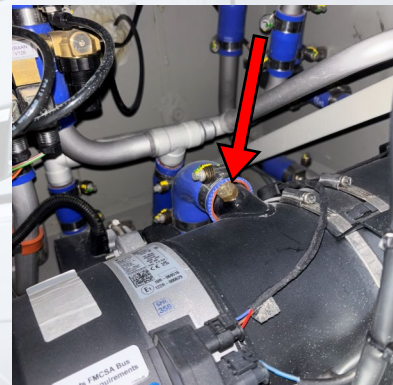
5. **Replace** the 17mm bolt and **tighten** by hand.
6. **Torque** to 14.75 ft-lbs (20 Nm).
