# SERVICE BULLETIN No.1174

<b>COACH MODEL</b>	: T2145 and C2045
<b>BULLETIN TYPE</b>	: Service Information
<b>MANUAL &amp; SECTION</b>	: Maintenance Manual: Chapter 11 – Body and accessories
<b>PARTS BOOK REVISION</b>	: No
<b>DATE</b>	: December 21, 2005
<b>SUBJECT</b>	: <b>Handling gas springs</b>
<b>TERMS &amp; CONDITIONS</b>	: No claims will be accepted with reference to this Bulletin.

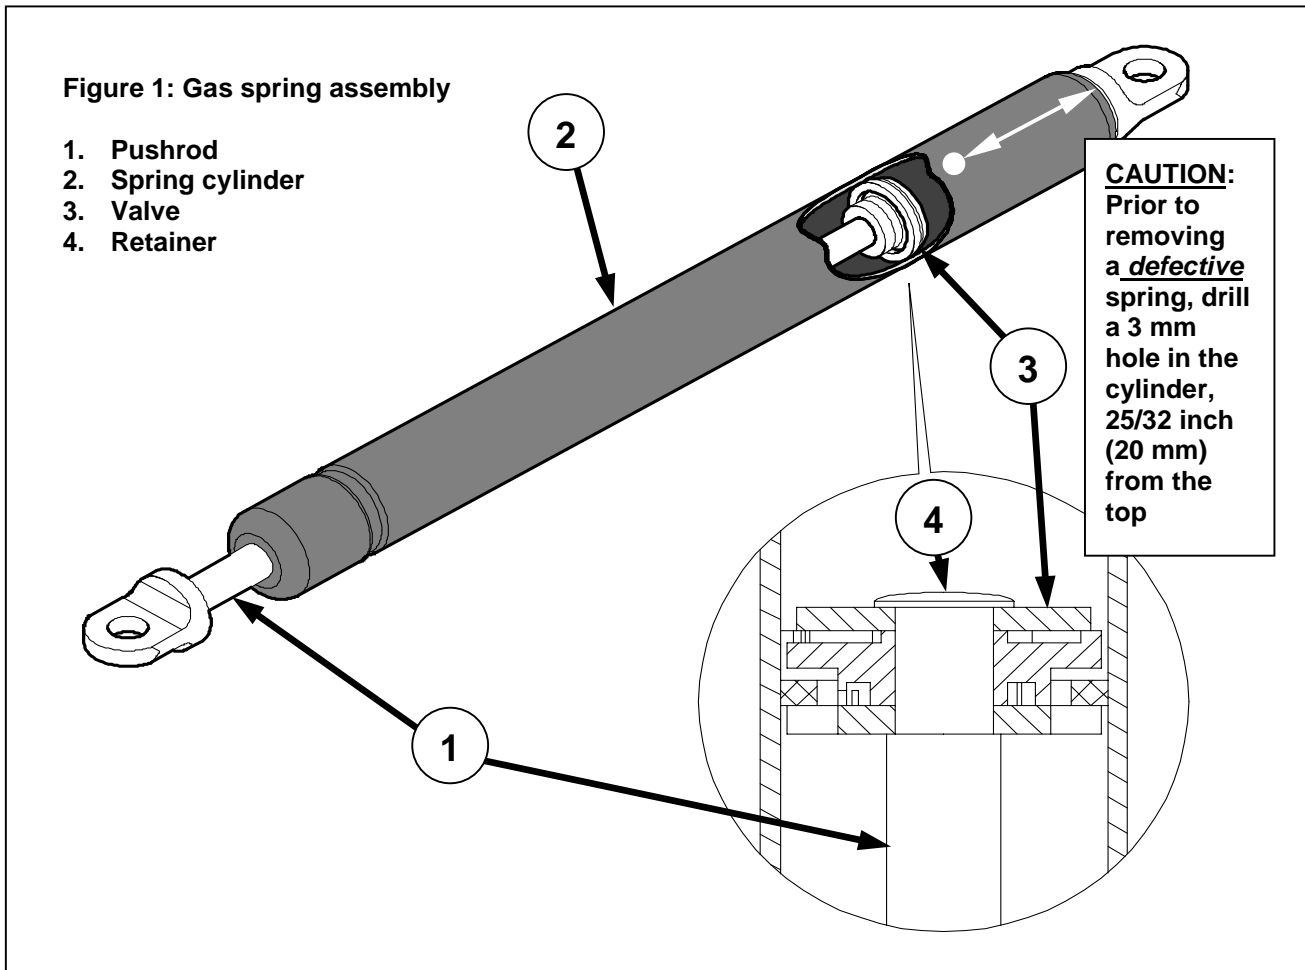
- assist closing them.
- The gas springs used may exert forces up to 180 lbf (800 N). A possibility of damage may therefore exist during removal of worn or defective gas spring from door mechanisms. Cases have been reported where the pushrod had separated from the valve inside the spring cylinder (see Figure 1, overleaf), thus leaving the rod without a positive stop. Upon removal, the residual gas pressure pushed the rod out of the spring cylinder with great force.

- The purpose of this Bulletin is therefore to warn service technicians and maintenance personnel that great caution should be observed when disassembling doors and door linkages.

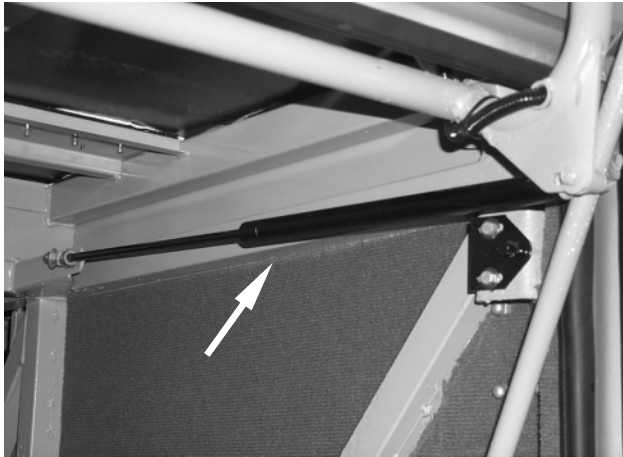
**Figure 2: Fully extended gas spring keeps door open**

Luggage and service doors can be opened by lifting the centrally mounted handle to unlatch the door and lifting it all the way up. The doors are kept in the open position by the gas springs (see Figure 2).

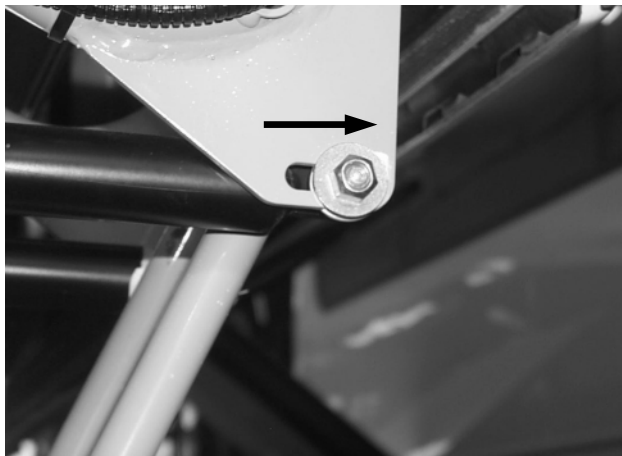
**Figure 5: Outward pivot movement in J-link bracket slot**

- 4) If the pivot has moved, this means that there is still pressure on the pushrod and that the valve no longer acts as a positive stop. Wearing safety glasses, proceed as follows:
  - At approximately 25/32 inch (20 mm) from the bottom of the spring cylinder, drill a 1/8 inch (3 mm) diameter and 25/64 inch (10 mm) deep hole in the cylinder wall (refer to Figure 1).
  - Allow gas and oil to escape.
- 5) With the residual gas pressure vented from the spring, extract the cotter pin and washer and withdraw the spring from the pivot (see Figure 6).

- 3) Undo but do not remove the nut securing the spring pivot to the J-link bracket (see Figure 5), while carefully watching the mounting pivot in the bracket slot for outward movement. With the spring at the end of its stroke, there shouldn't be any outward movement of the pivot.  
If the pivot remains steady (no movement), extract the cotter pin and washer and withdraw the strut from the pivot (see Figure 6).

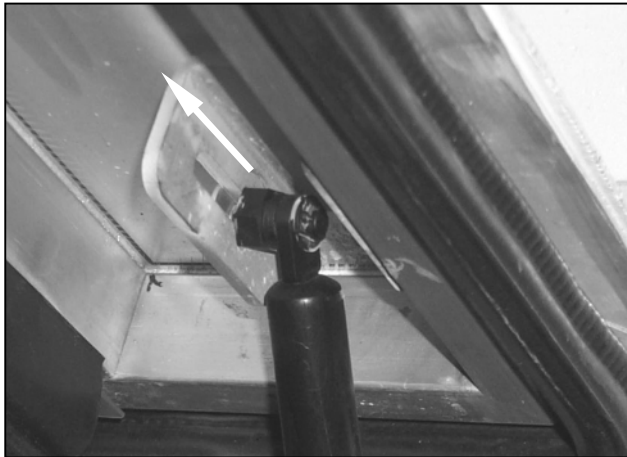
**Figure 8: Upward pivot movement in door bracket slot**

- 4) If the spring pivot has moved, this means that there is still pressure on the pushrod and that the valve no longer acts as a positive stop. Wearing safety glasses, proceed as follows:
  - At approximately 25/32 inch (20 mm) from the bottom of the strut cylinder, drill a 1/8 inch (3 mm) diameter and 25/64 inch (10 mm) deep hole in the cylinder wall (see Figure 1).
  - Allow gas and oil to escape.
- 5) With the residual gas pressure vented from the spring, remove the cotter pin and washer(s) and withdraw the spring from the pivot.
- 6) At the chassis bracket, undo and remove the nut, bolt and washer(s) securing the spring (see Figure 9).  
Remove the spring from the coach.

- 1) Open the access door.
- 2) With the spring(s) fully extended gently push the door further upward to check that the valve(s) butt(s) against the top of the cylinder.
- 3) Undo but do not remove the nut securing the spring pivot to the door mounting bracket while carefully watching the pivot in the bracket slot for upward movement (see Figure 8). With the spring at the end of its stroke, there shouldn't be any upward movement of the pivot.

If the pivot remains steady (no movement), extract the cotter pin and washer and withdraw the strut from the pivot (see Figure 8).
