Circulate to listed addressees

DESCRIPTION :

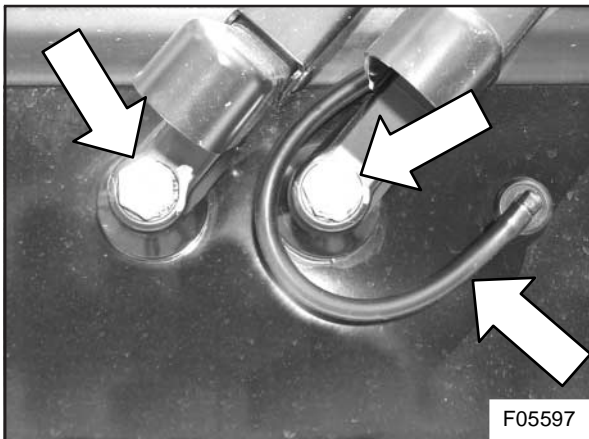
Figure 1: Wiper arm nuts and washer tube

- 1) Undo and remove the two nuts securing the main and idler windshield wiper arm (see Figure 1) on the right-hand side of the coach. Separate the washer tube from its fitting. Remove both wiper arms.

- 13) Tighten the wiper arm nuts to a torque of 18 ft.lbf (25 Nm). Reconnect the washer tubes to their respective fittings.
- 14) Check wiper arm and washer operation.

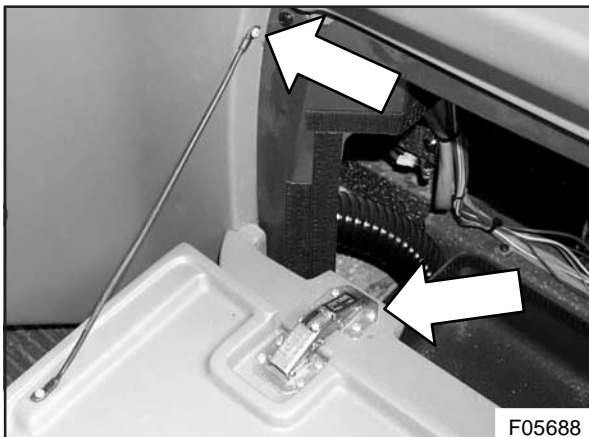
Figure 2: Road map compartment door check strap and hinge

- 2) Repeat step 1 for the left-hand wiper arm.
- 3) Open the road map compartment. Undo and remove the machine screws securing the two compartment door check straps (see Figure 2).

- 4) Undo and remove the machine screws securing the door hinges to the road map compartment (see Figure 2).
- 5) Remove the compartment door.

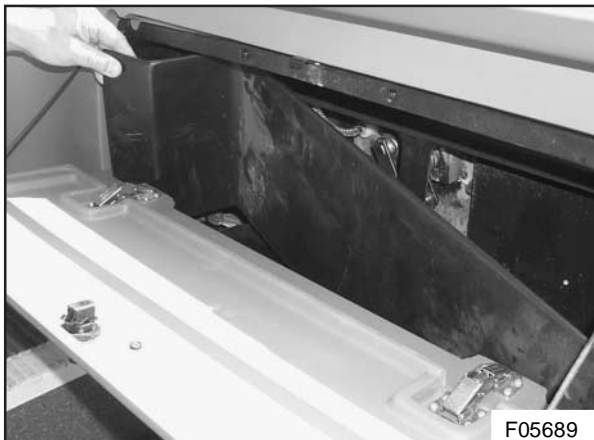
Figure 3: Compartment liner removal

- 6) Pull out the compartment liner, which is attached to the compartment back wall through Velcro strips (see Figure 3).

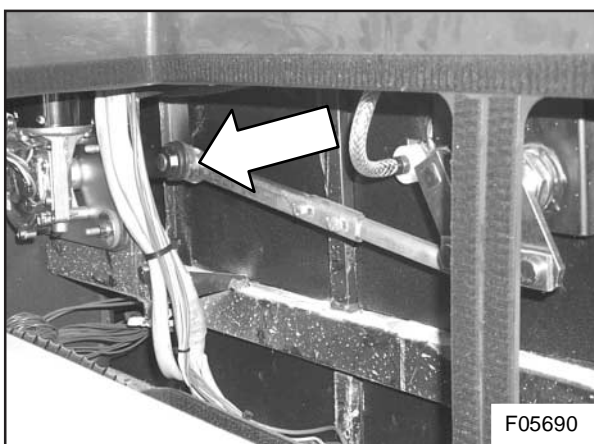
Figure 4: Bell crank and clamp location

- 7) Locate the bell crank and clamp behind the wiper motor mounting bracket (see Figures 4 and 6). With the wipers in the parking position and the wiper motor switched off, the bell crank and bracket are horizontal, i.e. parallel to the coach floor (see Figure 5). Carefully take note of their installation.

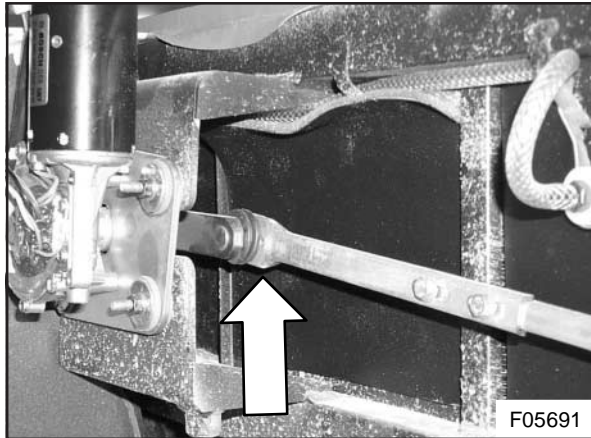
Figure 5: RH wiper tie bar inner knuckle

- 8) With a 1¹/₁₆" open-end wrench, lever the right-hand wiper tie bar from the bell crank knuckle joint (see Figure 5).
Make sure to recover the dust cap.
Take note of its installation.

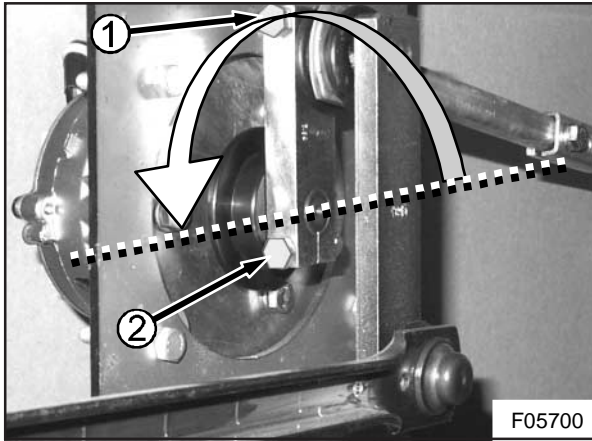
Figure 6: Bell crank and clamp after ¼ turn has been completed (left-hand tie bar up)

- 9) Switch the wiper switch to the slow wiping position. Turn the ignition on.
- 10) Using the master switch, activate the wiper motor and rotate the bell crank and clamp through 180° so that the left-hand tie rod becomes accessible.
Figure 6 shows the bell crank and clamp after ¼ turn has been completed (for the sake of clarity the picture has been taken from the front of the coach).
Turn off the wiper switch again.
Make sure the master switch is off.

- 11) With a 10 mm box wrench and a socket and ratchet undo the bolt and nut securing the bell crank to the clamp (see 1, Figure 6).
- 12) With a large screwdriver, separate the bell crank from the clamp.

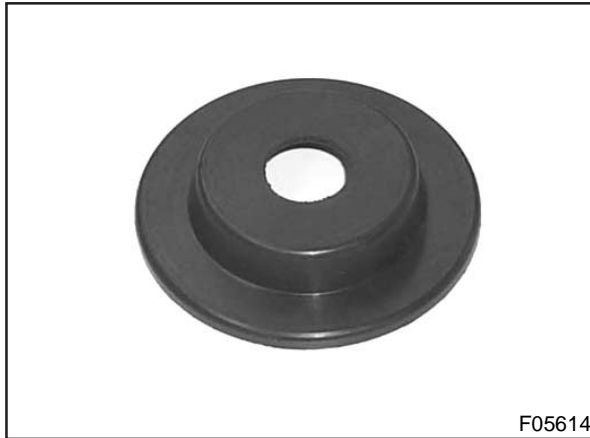
Figure 7: Wiper motor dust cap VH 10757900

To further improve wiper motor protection, a motor shaft dust cap should be fitted.

Install the motor shaft dust cap VH 10757900 (see Figure 7) by simply pushing it on the shaft as shown in Figure 8. Proper dust cap installation is shown in Figure 9.

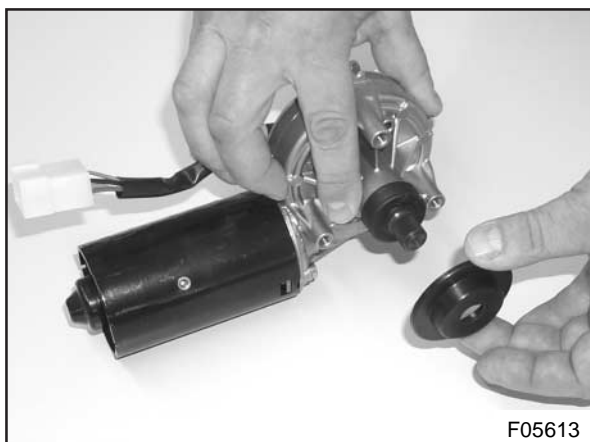
Figure 8: Wiper motor dust cap installation (for the sake of clarity shown with the motor out of the coach)

NOTE: There is no need to remove the motor from the coach in order to fit the dust cap. In Figure 8, dust cap installation is shown with the motor out of the coach for the sake of clarity.

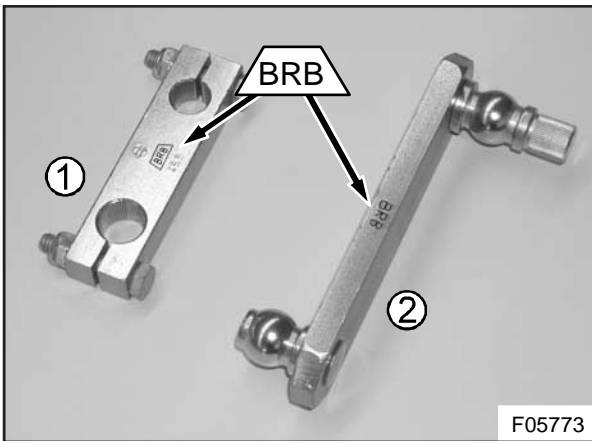
Figure 10: Clamp (1) and bell crank (2) with "BRB" mark.

- Reassembly is the reverse of disassembly.
- The new bell crank and clamp have been marked “BRB” (see Figure 10).
- Lightly lubricate the bell crank knuckles before installing the tie bars.
- Mind the tie bar dust cap installation.
- Make sure the bell crank knuckle shaft does not protrude through the clamp. The shaft end should be *flush* with the clamp.

- Parts will be forwarded to customers free of charge.
- Old and new parts are directly interchangeable.
- Only new parts will be offered as service replacements for this application.
- New bell crank and clamp can be identified by a "BRB" mark.
- Always use genuine maintenance products and parts. Do not accept imitations.

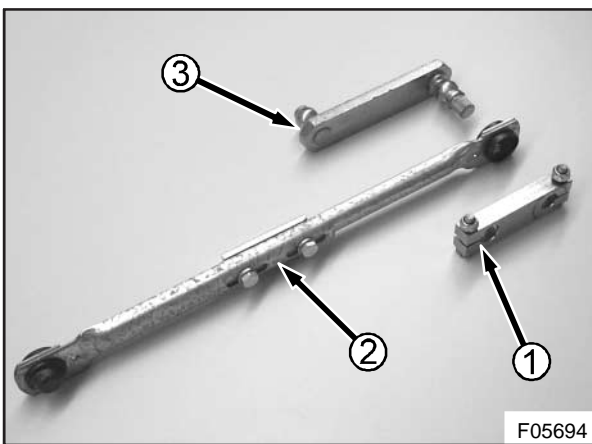
Figure 11: Relative position of wiper linkage parts

1. Clamp motor shaft mounting hole
2. Left-hand tie bar
3. Right-hand tie bar knuckle joint

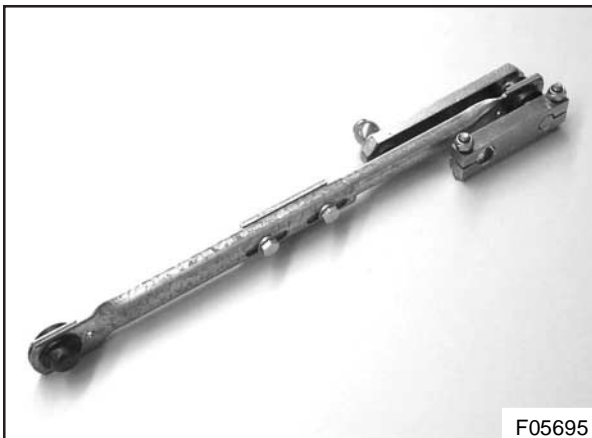
Figure 12: Bell crank and clamp assembled with left-hand tie bar

- 4) Lightly lubricate the splined knuckle joint before installing the left-hand tie bar. Install the dust caps and click the left-hand tie bar over the splined knuckle joint using rib joint pliers.
- 5) Push the knuckle joint in the splined hole of the clamp so that both are parallel and horizontal (see Figure 13).
- 6) Lightly lubricate the bell crank knuckle joint before installing the right-hand tie bar. Reconnect the right-hand tie bar to the bell crank knuckle joint using rib joint pliers.
- 7) Switch the wiper switch to the slow wiping position. Turn on the ignition.
- 8) Using the master switch, activate the wiper motor and rotate the bell crank and clamp through 180° so that the bell crank knuckle bolt becomes accessible. Make sure all switches are off.

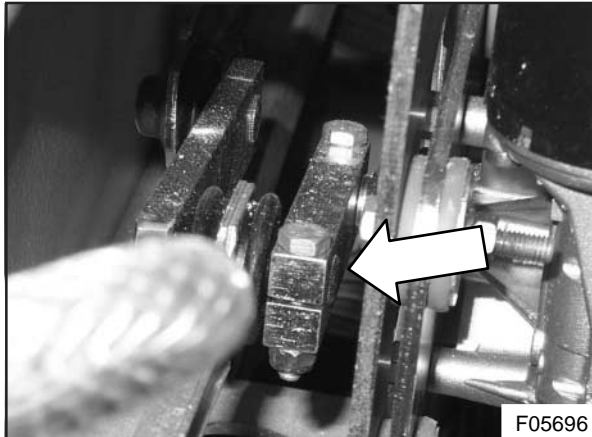
Figure 13: Linkage installed horizontally

- 2) Install the clamp horizontally on the wiper motor shaft with the knuckle joint mounting hole pointing towards the driver's seat (see Figure 13). Make sure the motor shaft end is *flush* with the clamp.

- 3) Tighten the motor shaft bolt of the clamp to a torque of 9 to 11 ft.lbf (12 to 15 Nm).

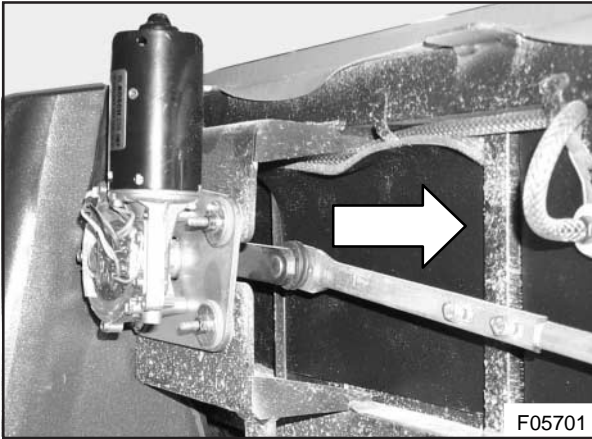
Figure 14: Wiper linkage, final installation with right-hand wiper tie bar pointing towards coach access door

- 10) Reset the wiper motor to the parking position by switching it to slow wiping and off again. Check that the bell crank and clamp are horizontal, with the right-hand wiper arm tie bar knuckle pointing to the coach access door (see Figure 14).

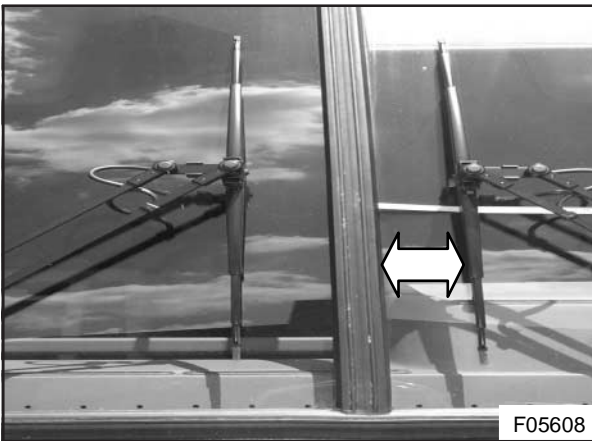
Figure 15: Wiper to windshield center post distance: $3 \frac{5}{32}$ inch

- 11) Reinstall the road map compartment liner and door. Refit the check straps.
- 12) Reinstall the left- and right-hand wiper arm assemblies. Before tightening the nuts, position the wiper arms as shown in Figure 15. The wiper blades should be about $3 \frac{5}{32}$ inch (80 mm) from the windshield center post (on a dry windshield).
