Water leaking in luggage bays right side.

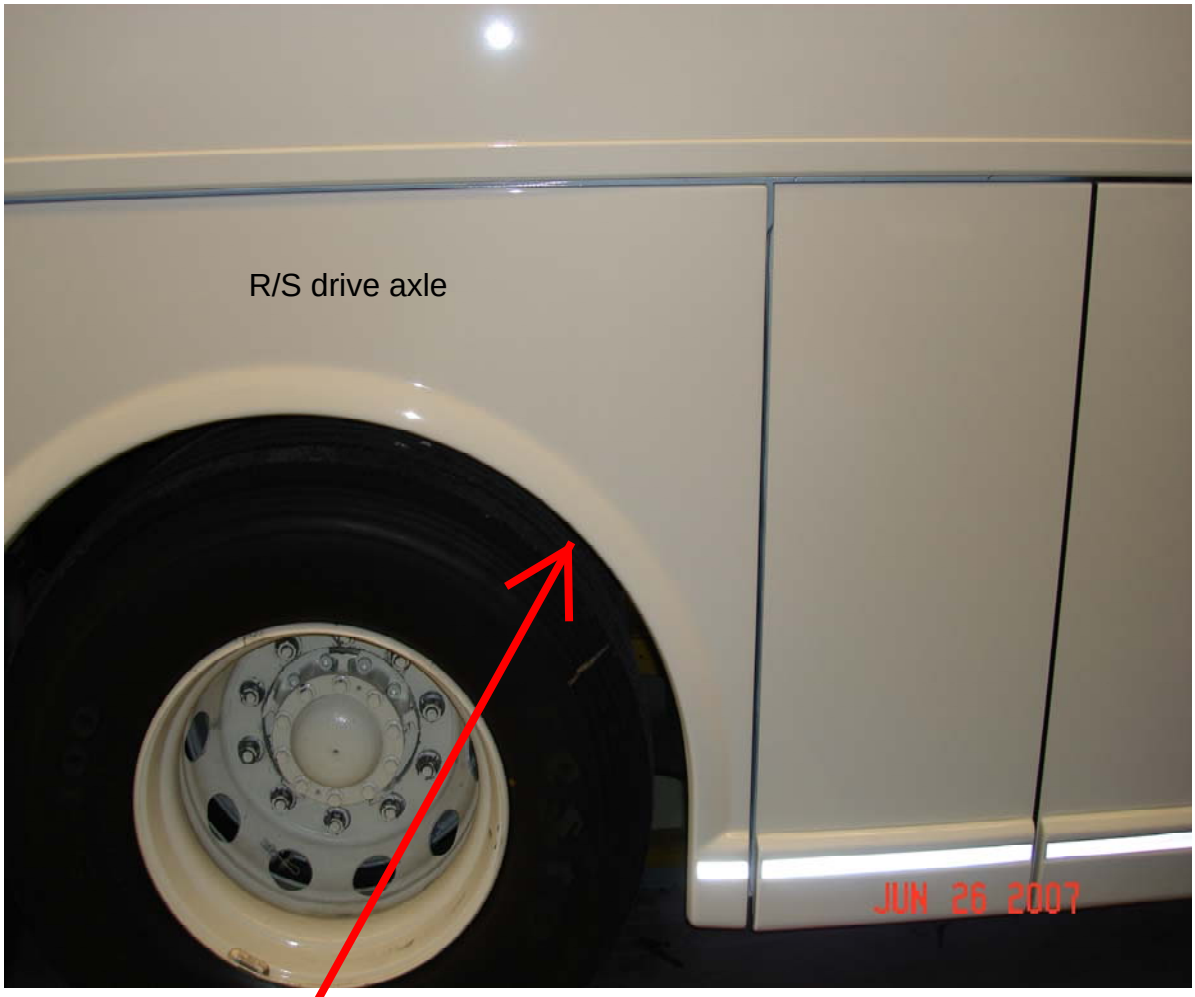
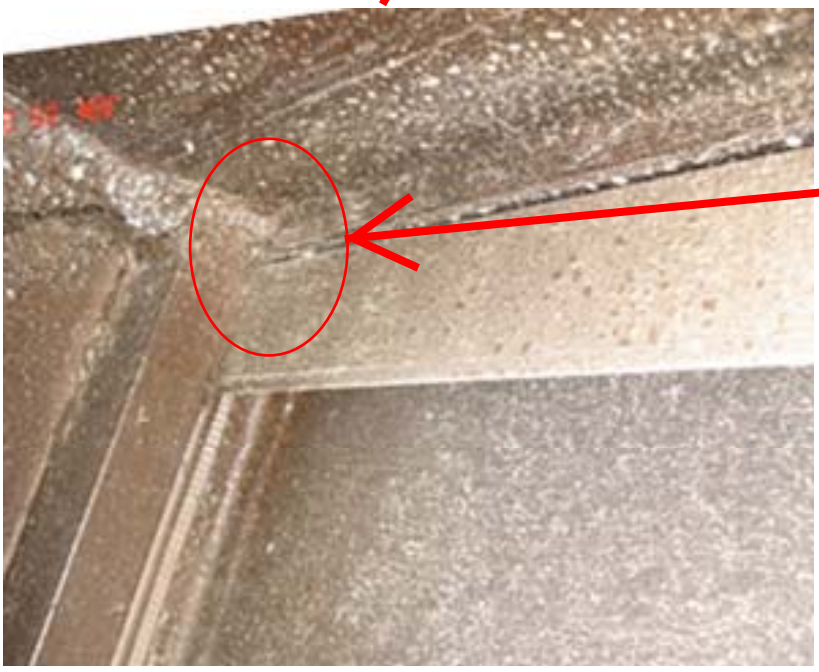
If the water is leaking into the luggage bay you will need to remove the wheel well cover and check to see if the channel in the top front corner of wheel well as shown it this picture is open with no sealer.

To repair the problem inject sealer into the channel, making sure to fill in the area.
