TECH TIPS

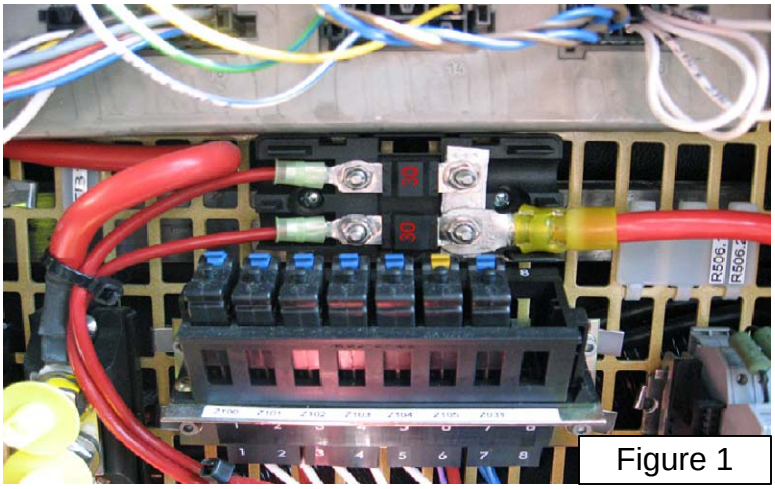
Figure 1

Because of installation inconsistency, with the VanHool fuse holders. It is therefore necessary to inspect the installation of these fuse holders to make sure that the system complies with the design specification. The inspection applies to the fuse holders in the right front dash electrical box. In (figure 1) shows the correct installation. In (figure 2 & 3) are the two possibilities of the incorrect installations.

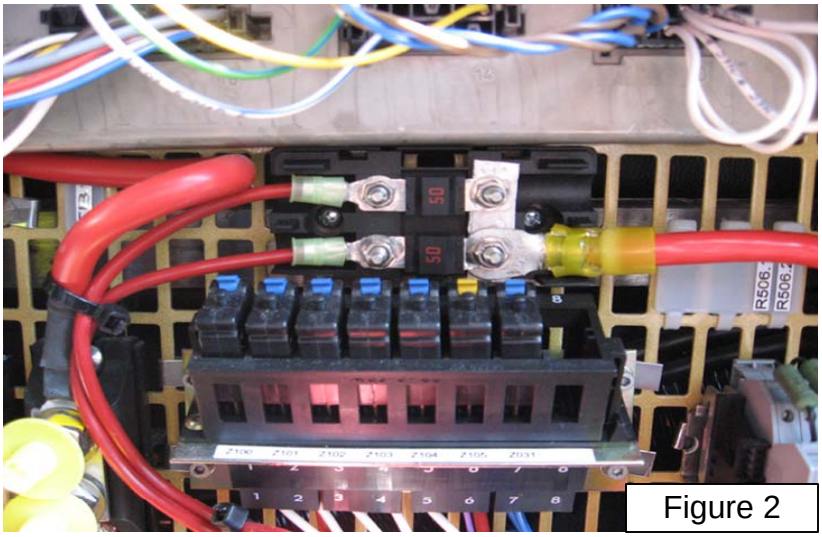
Figure 2

Here in figure 2 has the wrong fuses installed with two 50 amp fuses. They need to be replace with 30 amp fuses part number; 10930132.

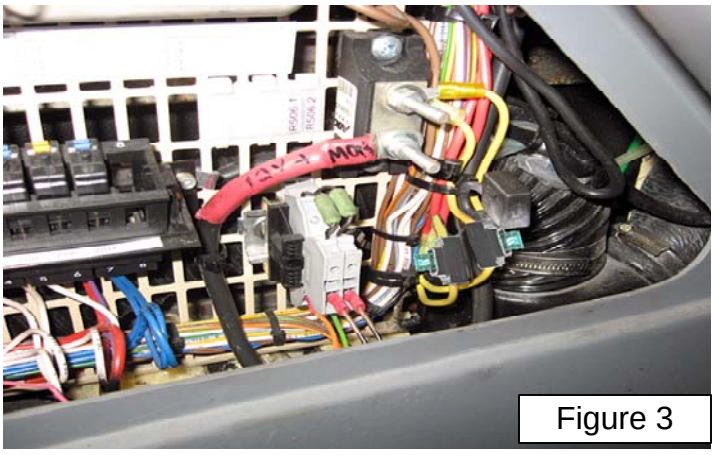
Figure 3

Here in figure 3 there was two inline fuses use that to be replace with the following part numbers; 10930132 (30 amp fuse) & 10947652 (4 fuse block, needs to be cut in half).
