COACH MODEL : VanHool coach models with Proheat installed

SUBJECT : Distorted combustion tube insert, may or may not log fault code

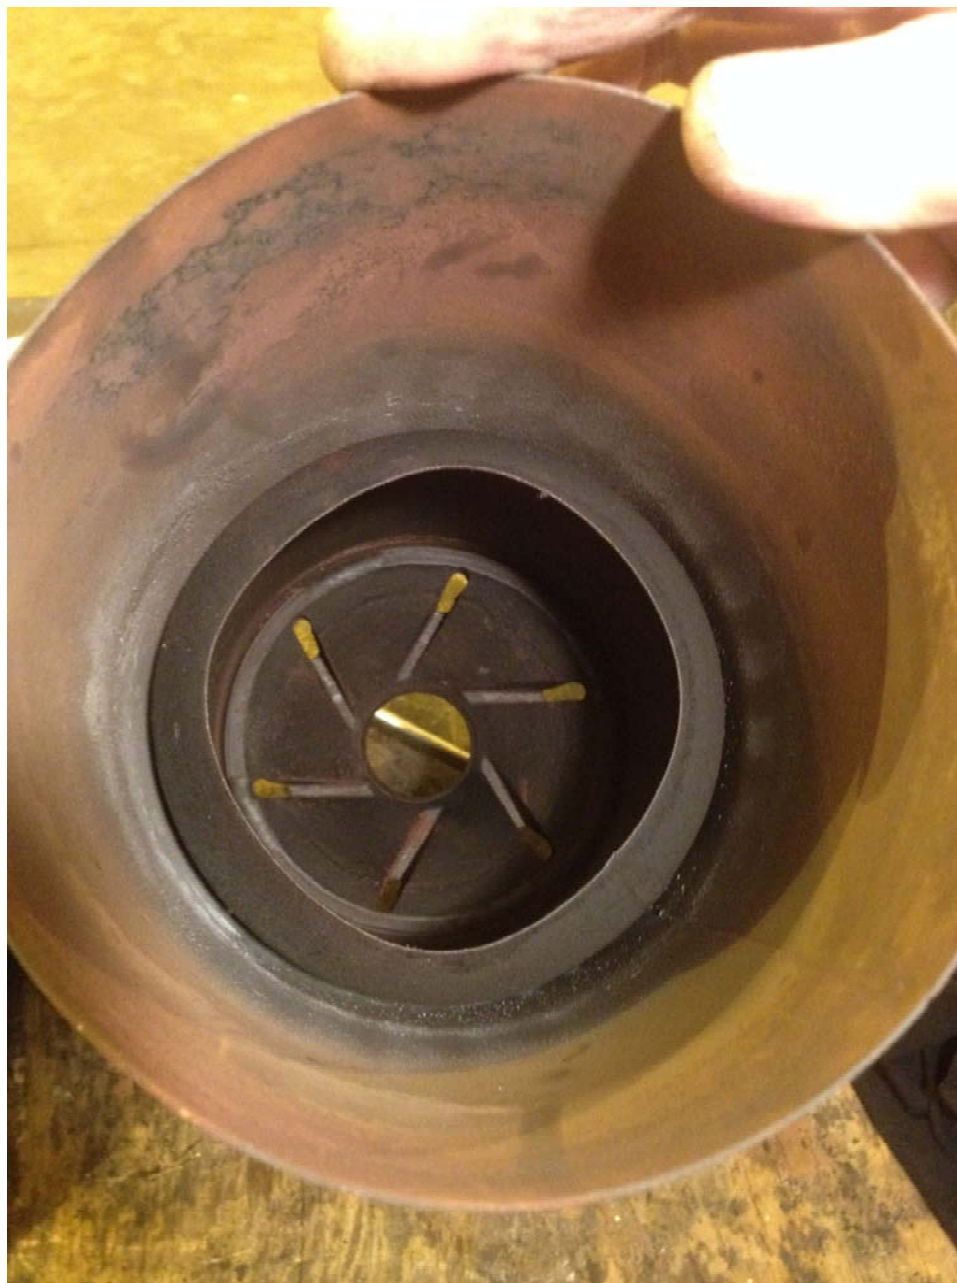
When inspecting a Proheat combustion heater unit for maintenance, or a no start condition with or without fault codes, pay close attention to the combustion tube insert.

If it is out of round like this one in this picture, the Proheat combustion heater may fire then shut off with no fault codes logged, or may log a start Diagnostic code #1.

If you find your the combustion tube is out of round, replace combustion tube.
