COACH MODEL : CX45, CX35
DATE : April 1, 2020
SUBJECT : No Crank, Rear Engine Door Sensor

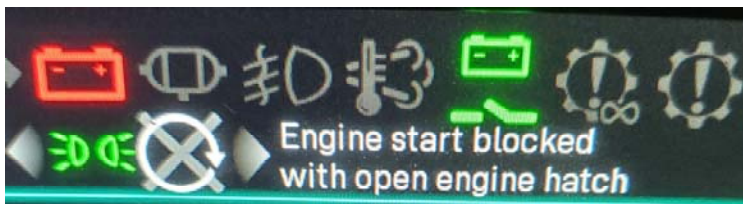
The message shown above on the MVP Dash Display alerts the driver if the door is left open.

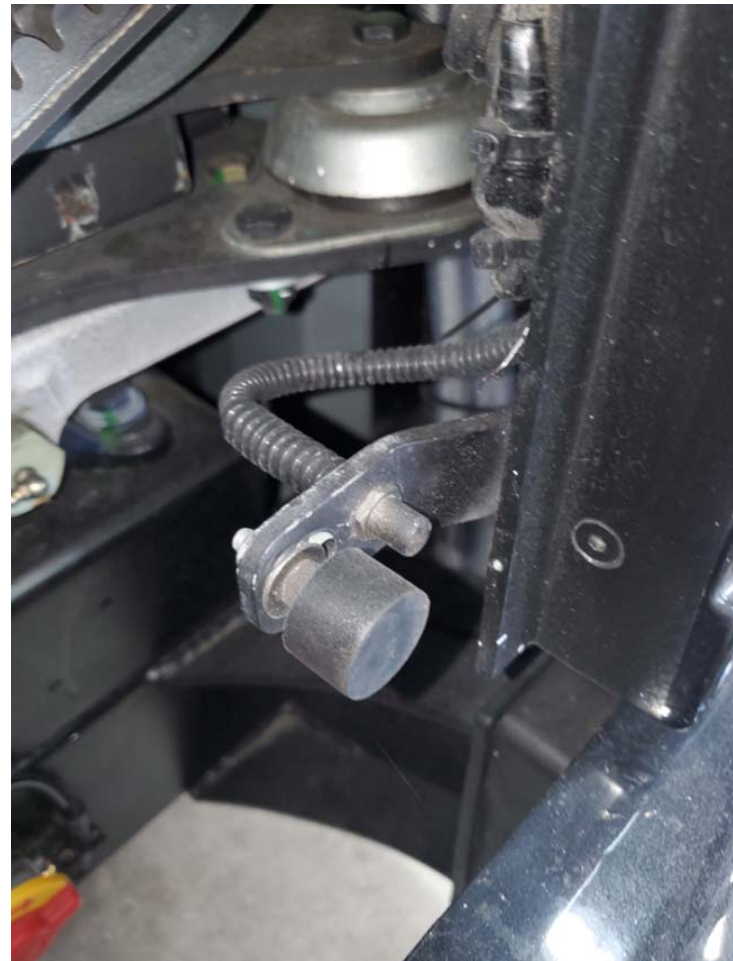
Right side sensor shown above, left side similar.

The sensors are similar to wheelchair door sensors and operate in the same manner. The engine door must be closed, which magnetically closes the switches and allows the engine to crank from the drivers start button.

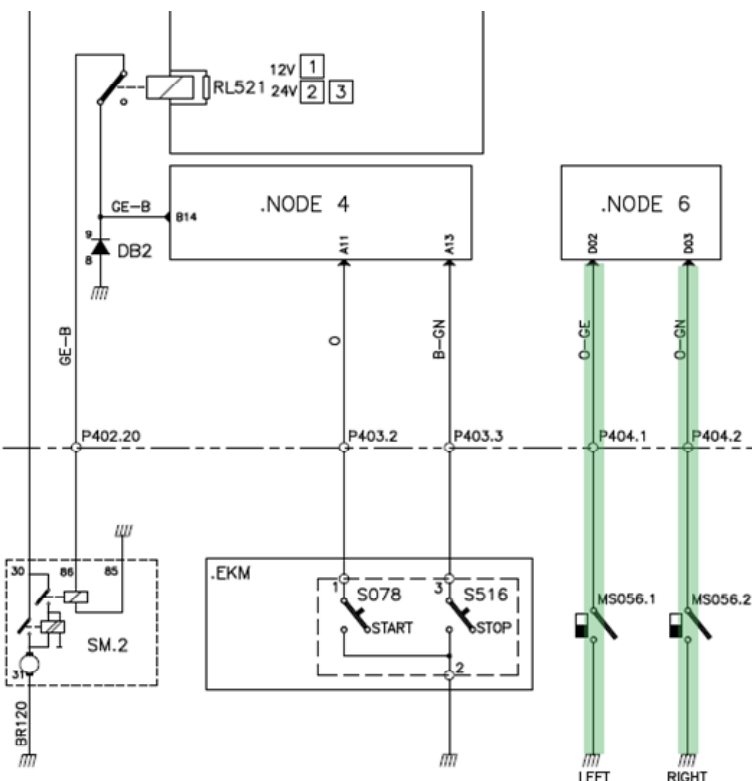
There are two switches that are located on the left and right side of the engine compartment (refer to the electrical schematic below).
