**COACH MODEL :** CX 35 and CX 45  
**DATE :** November 20 2022  
**SUBJECT :** Wiring Modification when replacing complete mirror assembly

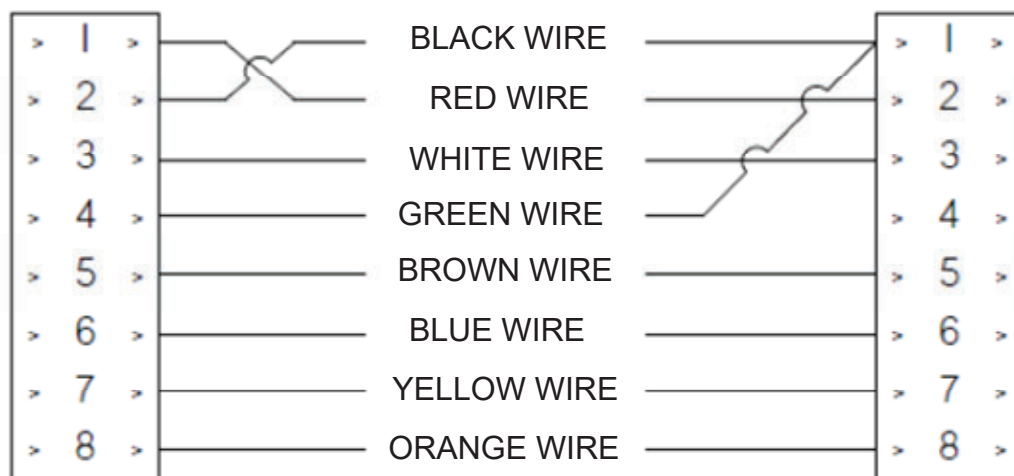
The diagram below shows the factory plug on the left and the modified plug on the right .

Older coaches use a 3-pin control for the mirrors and the new mirrors use a 4-pin control setup. In order to remedy this, the 8-pin plug on the coach side must be rewired as follows:

Remove Pins 1,2, and 4 (should be red, black, and green wires, respectively)  
 Cut off the terminals of pins 2 and 4.  
 Crimp wires from pins 2 and 4 together into a new pin and insert into pin 1.  
 Insert wire from pin 1 into pin 2.

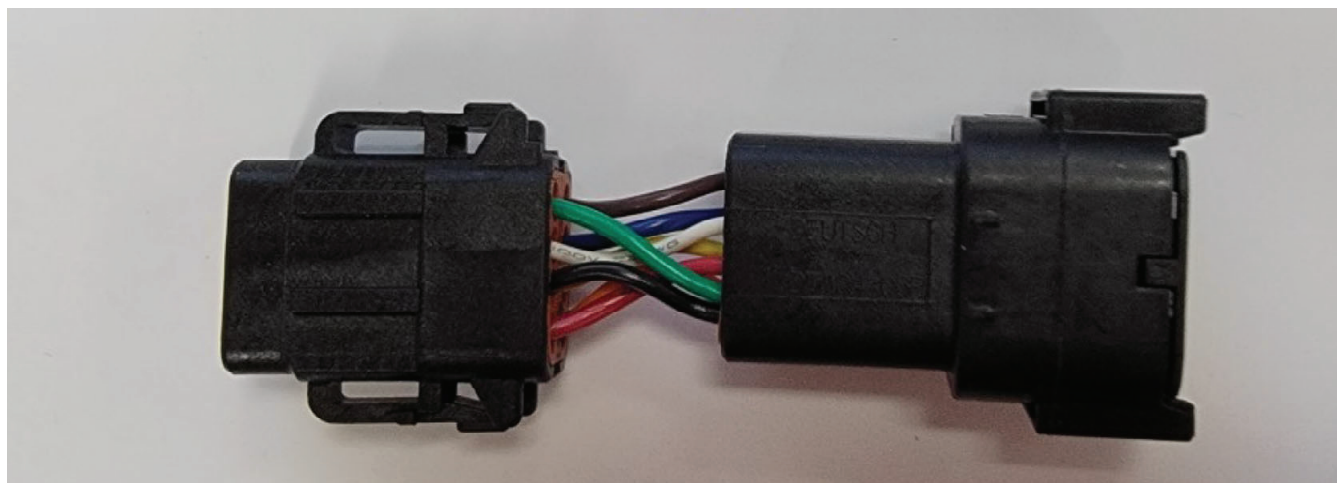
Moving forward, a plug and play adapter harness will be provided with a new mirror purchase. When replacing the mirror simply install the harness shown below to avoid wiring modifications. The adapter harness is not available separately.
