COACH MODEL : 2023 & 2024 CX 35
DATE : January 8 2024
SUBJECT : Air Filter Restricted Warning on MVP

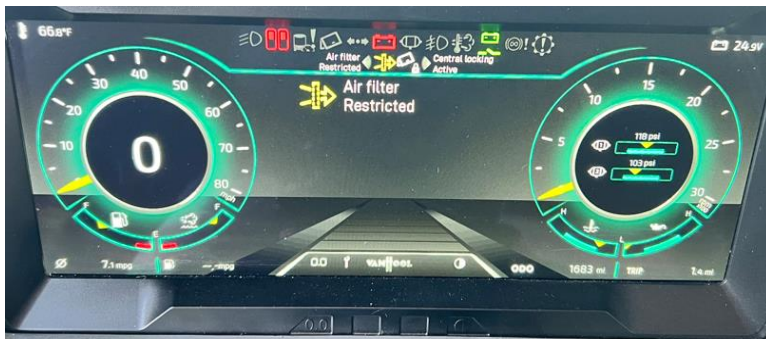
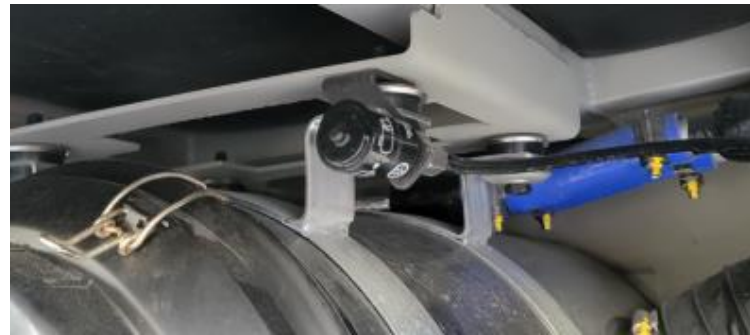
Beginning in 2023, VanHool implemented an electronic air filter monitor sensor for the CX 45. The CX 35 will gradually adopt this change, but at present, it continues to utilize a non-electric filter monitor as depicted below. Despite this, the wiring for the CX 35 has been prepared for the transition, potentially causing a false warning on the MVP if the connector touches a grounded source.

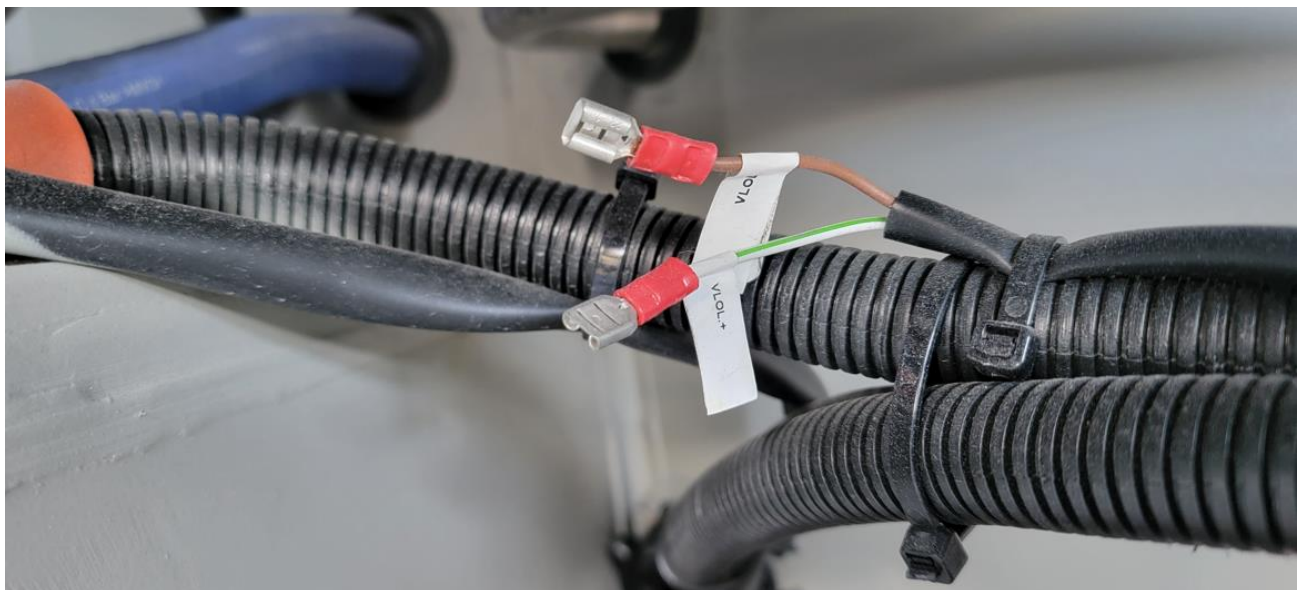
The connectors, situated close to the air filter, lack insulation and are labeled with the lettering "VL0L." Among these connectors, the white wire with a green tracer serves as the input to NODE 6. Upon activation of the filter minder due to a dirty air filter, this specific wire—white with a green tracer—will provide a ground connection to NODE 6 through the brown wire. It's essential to individually insulate each wire and securely fasten them to the harness using tie wraps
